June 1969

The Effect of Heat Treatment
on the
Fracture Toughness and
Subcritical Crack Growth
Characteristics of a 350-Grade
Maraging Steel

C. S. Carter

Boeing Commercial Airplane Group
Renton, Washington

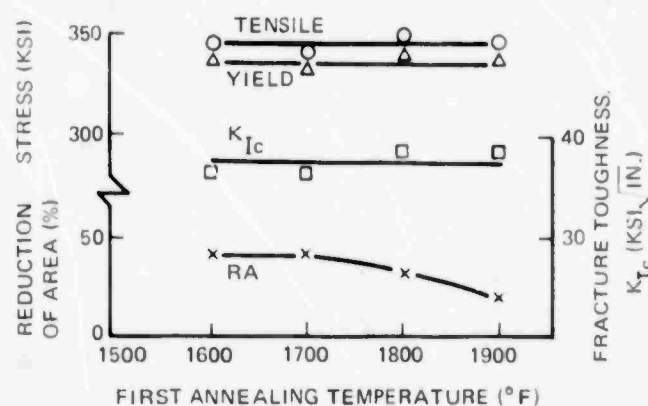
Fig. 1. Effect of first annealing temperature on mechanical properties (second anneal at 1500°F/1 hr and aged 900°F/8 hr).

The effect of double solution annealing on the properties of the 4-in.-square billet was examined, and the results are shown in Figs. 1 and 2. The first annealing temperature had no significant effect on tensile properties except that the reduction of area was less when the annealing temperature exceeded 1700°F (Fig. 1). This

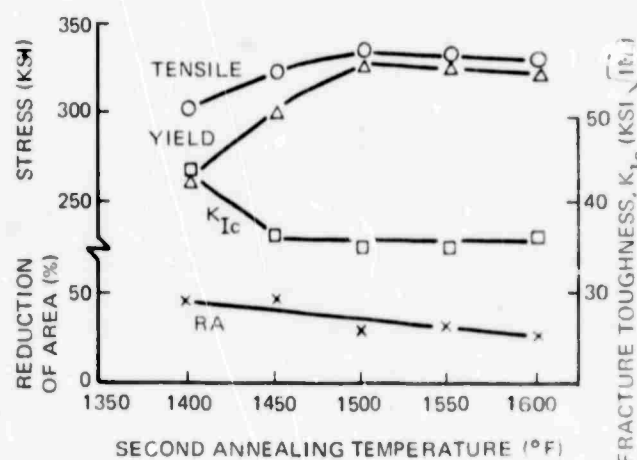
Fig. 2. Effect of second annealing temperature on mechanical properties (first anneal at 1700°F/1 hr and aged 900°F/8 hr).

could be associated with grain growth. Fracture toughness K_{Ic} , however, was independent of annealing temperature. As indicated in Fig. 2, the second annealing temperature should exceed 1450°F. Annealing below this temperature gave lower tensile properties since some austenite was present. Therefore, for the remainder of this study, the specimens were double solution annealed at 1700°F for 1 hr followed by 1500°F for 1 hr.

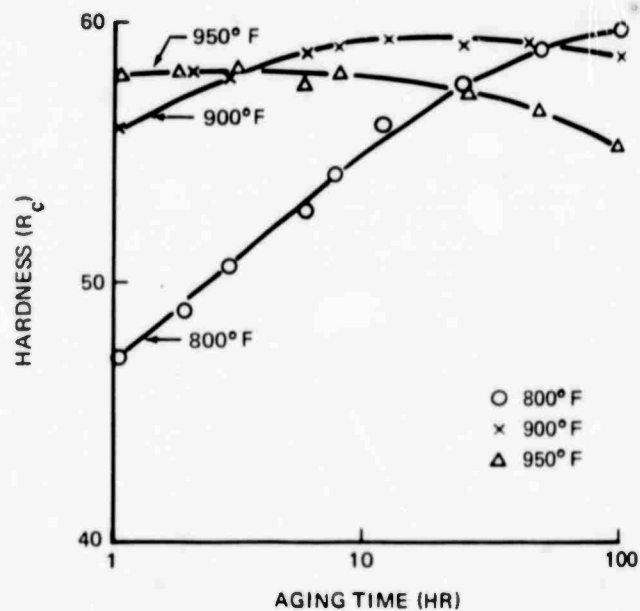
Fig. 3. Effect of aging on hardness (double solution annealed 1700° F/1500° F).

The hardness behavior of the 4-in.-square billet aged at various temperatures for times up to 100 hr is shown in Fig. 3. The curves are typical of precipitation hardening alloys, with maximum hardness being achieved after aging at the lower temperature for a longer time.

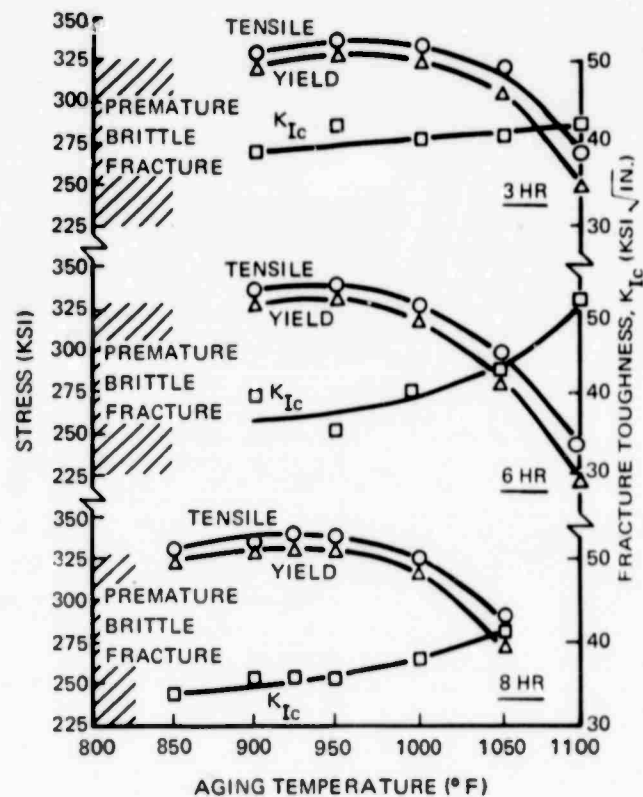
Fig. 4. Effect of aging on mechanical properties (double solution annealed 1700° F/1500° F).

The effect of aging temperature on the tensile properties and fracture toughness of the same material is shown in Fig. 4. Significant differences in behavior were observed between specimens aged at less than 900° F and those aged at higher temperatures. Because of this, the two temperature regimes are discussed separately below.

Aging at temperatures above 1000°F led to a marked reduction in tensile properties (Fig. 4). The amount of reverted austenite retained after aging at various temperatures for 3 hr is shown in Fig. 10, and comparison with Fig. 4 shows the decrease in strength could be associated with reverted austenite; however, some of the austenite formed during aging may have transformed to virgin (unaged) martensite upon cooling to room

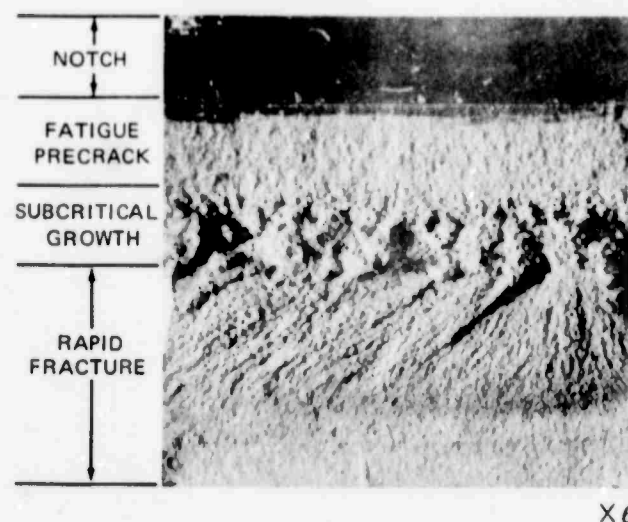
Fig. 6. Subcritical crack growth in a notched bend specimen tested under rising load in laboratory air (aged 800°F/3 hr).

An identical phenomenon was observed in the fracture toughness tests. Subcritical crack growth commenced during loading, and the crack extended until rapid failure occurred at maximum load (Fig. 6). This was eliminated by increasing the loading rate (crosshead speed increased from 0.05 in./min to 2 in./min). In specimens exhibiting crack growth, K_{Ic} was computed from the maximum load and the distance from the surface containing the notch to the position where subcritical crack growth terminated. Values determined in this way were significantly higher than the K_{Ic} obtained by rapid loading (Table IV). This was unlikely to be a strain rate effect because other investigations have shown that the fracture toughness of maraging steel is essentially independent of strain rate (8).

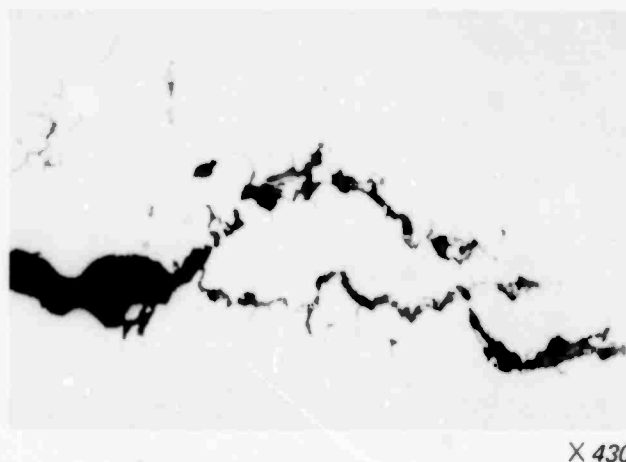
Fig. 7. Microscopic crack branching in a notched bend specimen tested under rising load in laboratory air (aged 800°F/8 hr).

Metallographic examination of the subcritical crack growth region revealed an intergranular mode of cracking with the cracks tending to

branch on a microscopic scale (Fig. 7). Possibly these microscopic branch cracks were sufficient to dissipate the applied load and effectively blunt

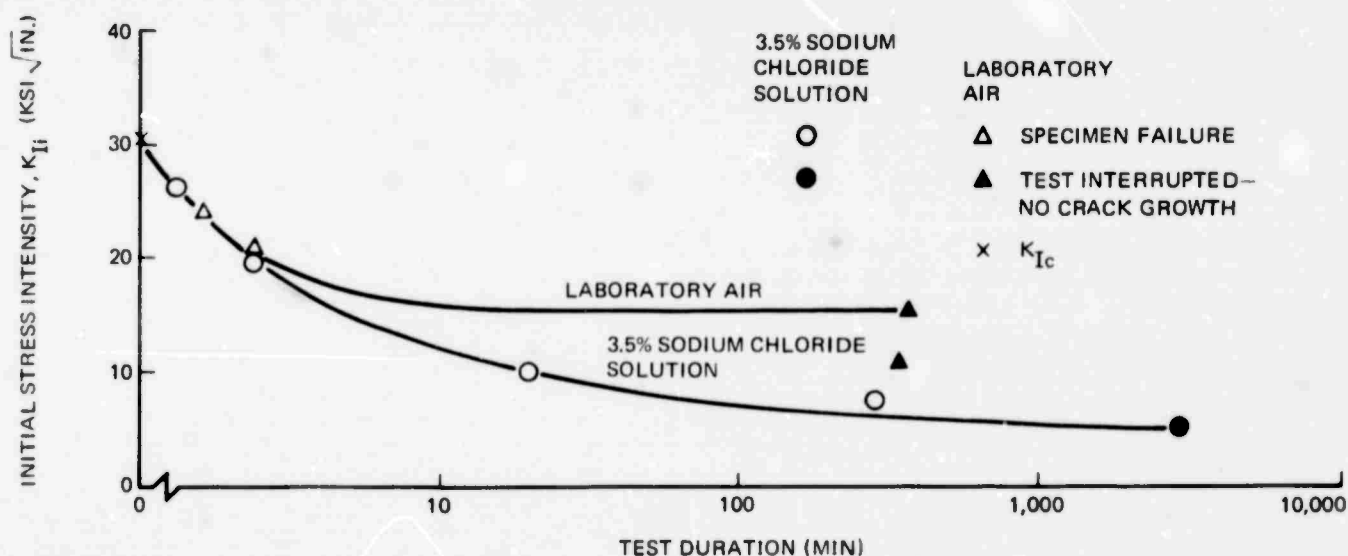
Fig. 8. Subcritical crack growth resistance (aged 800°F/8 hr).

To quantitatively measure the resistance to crack growth, precracked Charpy specimens were cantilever loaded to selected stress intensity levels in laboratory air and the time to failure established. The results, shown in Fig. 8, indicate that crack growth did not occur below a stress intensity level of 15 ksi $\sqrt{in.}$ This information can be used to explain the mechanics of fracture in the tension specimens.

Resistance to crack growth was similarly determined in 3-1/2% aqueous sodium chloride solution (Fig. 8). Threshold stress intensity was

reduced to 5 ksi $\sqrt{\text{in.}}$ in this environment although the times to failure at stress intensities exceeding 20 ksi $\sqrt{\text{in.}}$ were similar to those recorded in air. Crack growth measurements revealed that crack velocity was directly proportional to applied stress intensity (Fig. 9).

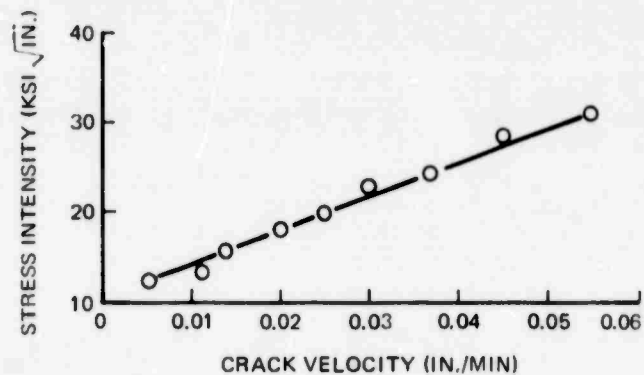
Fig. 9. Relationship between stress intensity and crack velocity (aged 800°F/8 hr).

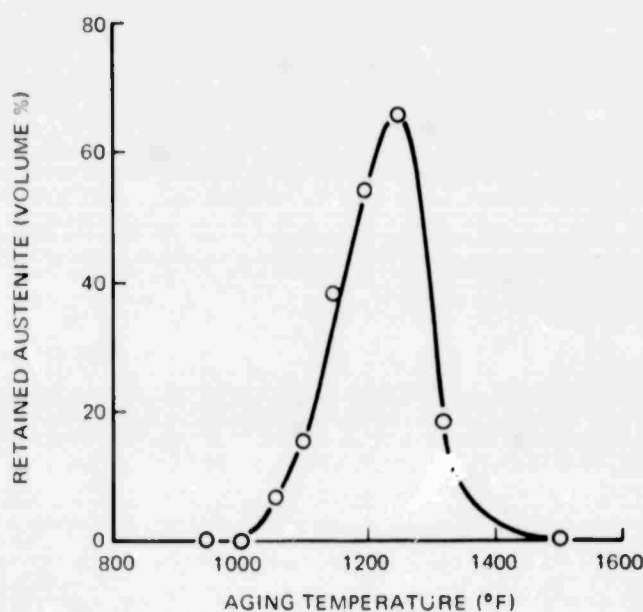
Fig. 10. Austenite retained at room temperature after aging for 3 hr (bar material).

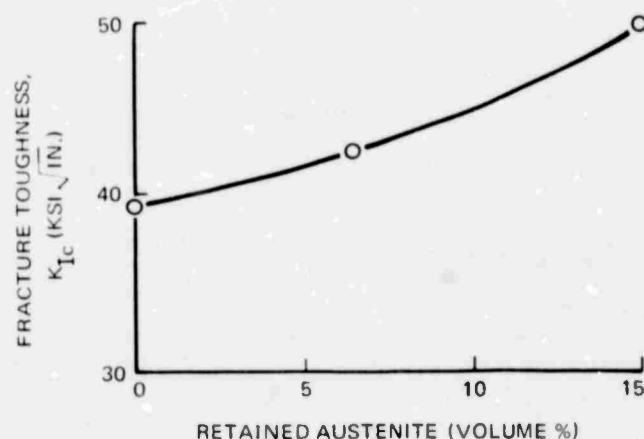
Fig. 11. Influence of retained austenite on fracture toughness.

temperature and would also contribute to the observed strength reduction. Unfortunately, the reverted austenite only slightly improved the fracture toughness (Fig. 11). This may be

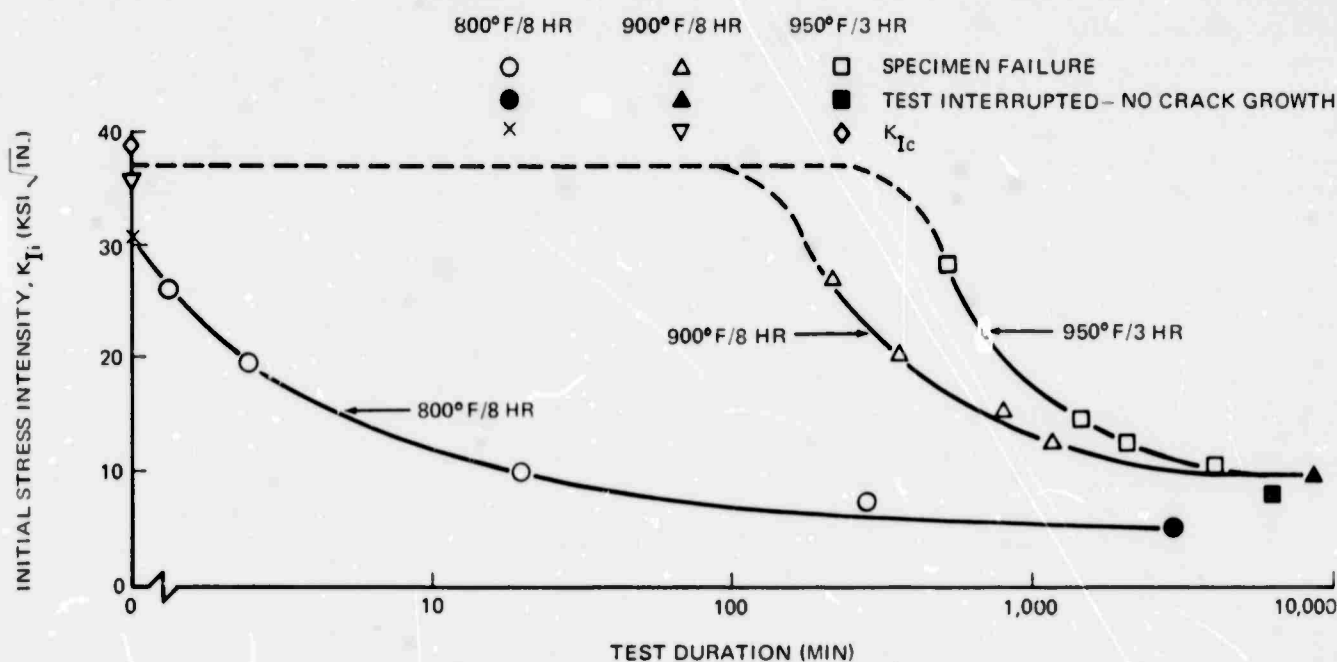
Fig. 12. Effect of aging treatment on subcritical crack growth resistance in 3.5% aqueous sodium chloride solution.

The crack growth resistance of 900° and 950° F aged specimens, statically loaded in 3.5% aqueous sodium chloride solution, is shown in Fig. 12. The threshold stress intensity was 10 ksi $\sqrt{\text{in.}}$ and the crack velocity was constant (independent of stress intensity) at approximately 0.0006 in./min, for both heat treatment conditions. Both the threshold level and the time to failure at a given initial stress intensity were increased relative to the 800° F aged condition, which is shown for comparison in Fig. 12. It was not apparent why the crack velocity changed from a stress intensity dependency to a constant, and much slower, rate when the aging temperature was increased from 800° to 900° or 950° F; the fracture mode was intergranular for all heat treatments.

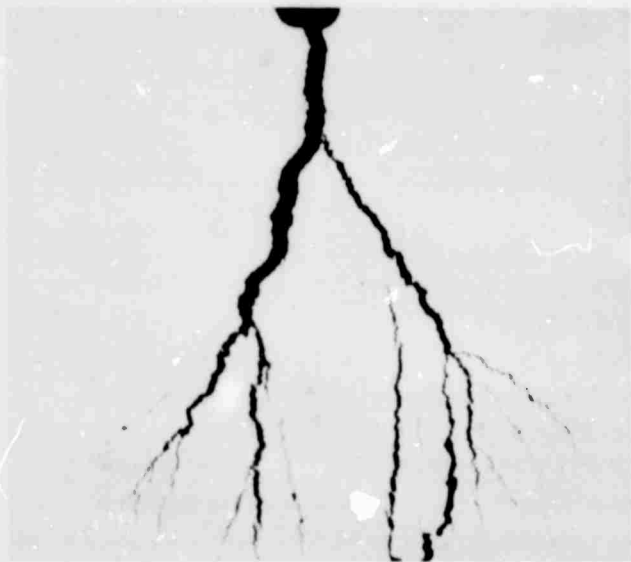
Fig. 13. Macroscopic crack branching in notched bend specimen loaded to $K_{II} = 27 \text{ ksi}\sqrt{\text{in.}}$ in 3.5% aqueous sodium chloride solution (aged $900^\circ\text{F}/8 \text{ hr}$).

The cracks were extensively branched on a macroscopic scale in both heat treatment conditions (Fig. 13). This can be contrasted with 800° F aged specimens in which there was no evidence of macroscopic branching and the crack velocity was directly proportional to stress intensity. As discussed elsewhere, branching only occurs when the crack velocity is essentially constant and a critical stress intensity level is attained (16).

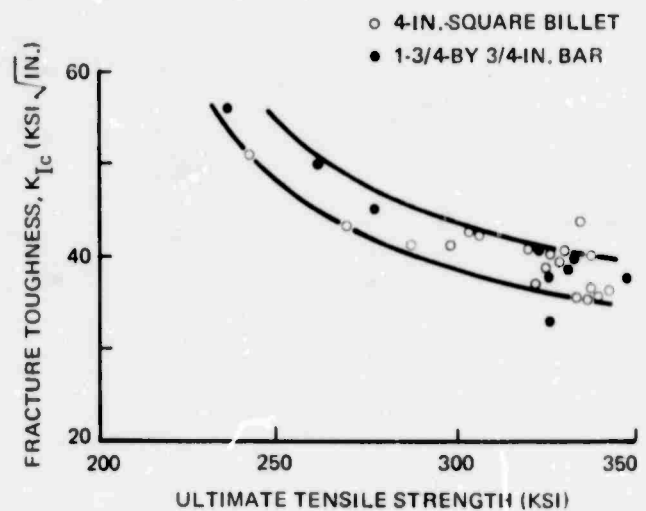
Fig. 14. Relation between strength and toughness for bar and billet (aged at various temperatures above 850°F).

be achieved. Therefore, the individual results are not recorded here, but the relationship between strength and K_{Ic} for material aged at temperatures in the range 900° to 1100°F is shown in Fig. 14 for both billet and bar material. The poor tradeoff between decreasing strength and toughness is apparent and emphasizes the ineffectiveness of reverted austenite as a crack stopper.

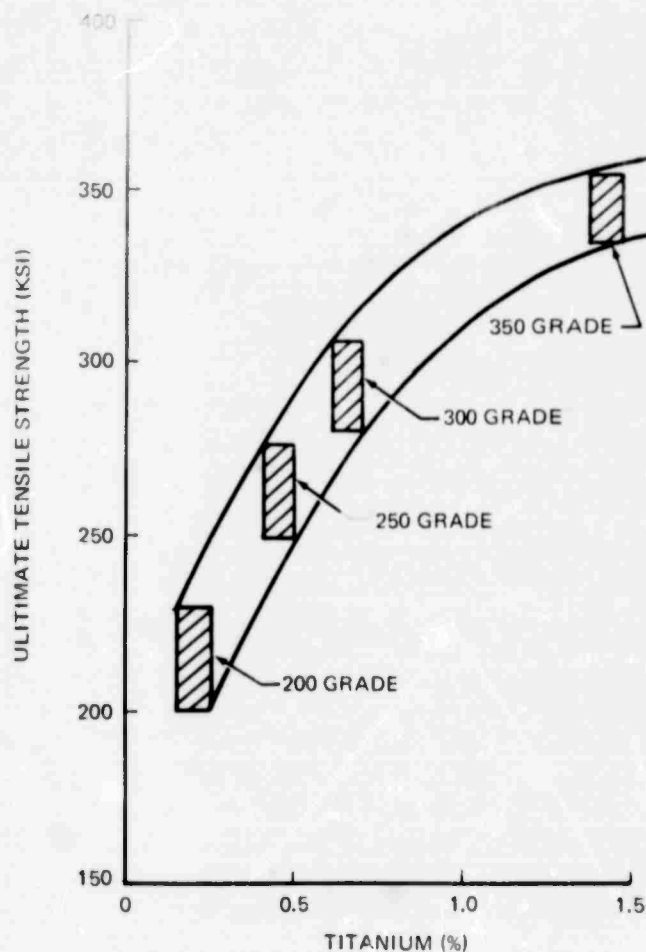
Fig. 16. Influence of titanium content on ultimate tensile strength.

In the tensile strength range 180 to 350 ksi, the strength level of maraging steels is primarily increased by raising the titanium content. The effect of this element is shown in Fig. 16 using typical values of strength and titanium content for each grade. It is apparent that titanium is much less effective in strengthening when the content exceeds 1%, particularly when it is remembered that the cobalt content of the 350 grade is approximately 4% higher than in the other grades.

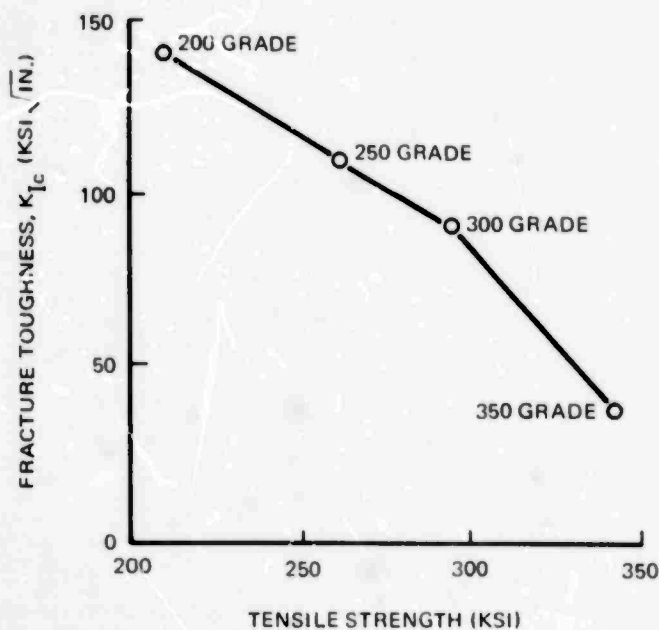
Fig. 17. Relationship between tensile strength (typical) and fracture toughness (optimum).

The relationship between strength and fracture toughness (Fig. 17) indicates that K_{Ic} rapidly decreases with strength level in the range 300 to 350 ksi. This can be associated with the high titanium contents (1.0% to 1.5%) in this strength range because, as shown in Fig. 18, the fracture toughness is inversely related to the titanium content.

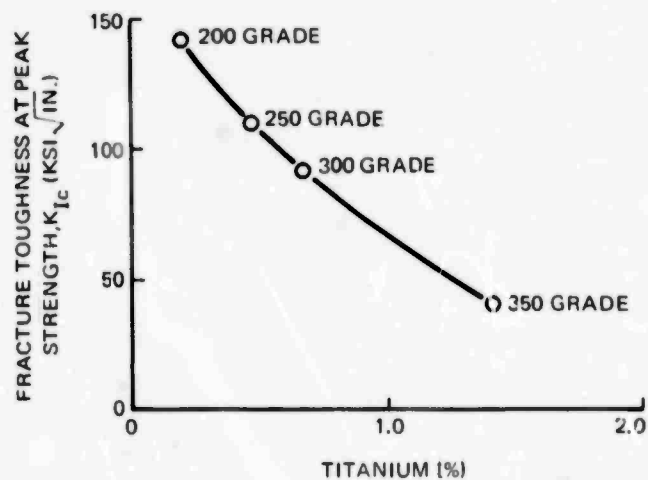
Fig. 18. Influence of titanium content (typical) on fracture toughness (optimum) values.

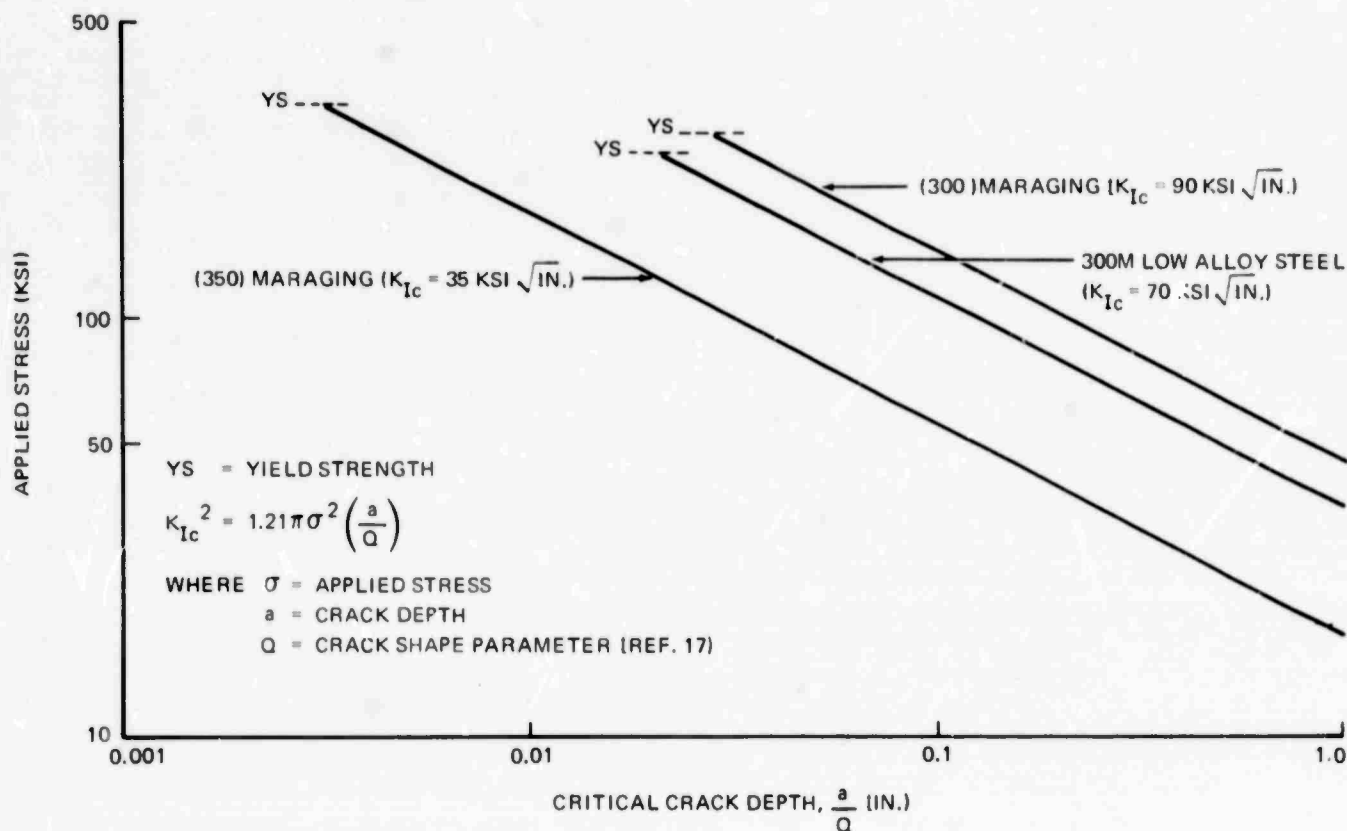
Fig. 19. Comparison between critical crack sizes in 350-grade maraging steel and other high-strength steels.

estimate can be made of the critical crack size as a function of applied stress. Such a plot is shown in Fig. 19 for 350-grade maraging steel (at maximum strength) and compared with similar relationships

for 300-grade maraging and 300M low-alloy steels heat treated to the 280 ksi ultimate tensile strength level. For a given applied stress level, the critical crack size is significantly less than the lower strength steels. Furthermore, it must be remembered that design stresses are often a function of ultimate tensile strength. Allowing for such an increase in applied stress indicates that the critical crack size in 350-grade steel will be approximately five times less than in 300M (a widely used landing gear alloy). This does not of course mean that brittle fracture will occur in structural components made from this maraging steel, but this significant decrease in critical crack size must be carefully considered in relation to the structural weight saving offered.
